# A 1.2 Mapping of priority intervention areas and related impact classes

# A 1.2 Mapping of priority intervention areas by morpho-typological class

Italy – Croatia

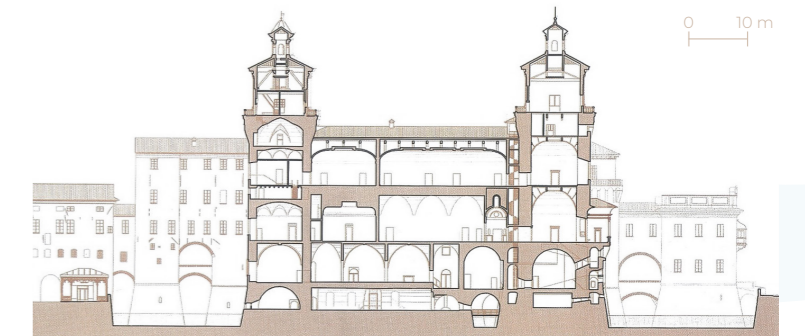
- a. Section including Torre Marchesana and Torre dei Leoni.
- b. Aerial view of the west side of the castle.
- c. A ground-floor room in the north wing of the Castle features frescoed decorations that originally adorned the exterior walls of the Rocca dei Leoni, when in the 15th century was still separate from the Castle.
- d. Detail of the east side of the Castle with a stone balustrade.
- e. View of the colonnade in the courtyard.

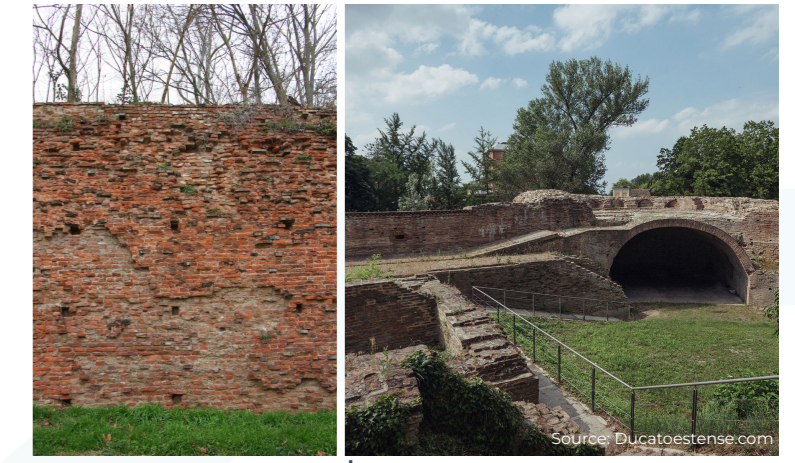
- a. Detail of the brick masonry of the walls (southern stretch).
- b. Torrione del Barco (NW corner of the city walls), it is part of the fortifications constructed between 1493 and 1506 to protect the "Addizione Ercolea". (Image: Ducatoestense.com)
- c. The Baluardo of Santa Maria is a testament to the pentagonal star-shaped fortress constructed between 1608 and 1618 by order of the Pope.
- d. View of the northeast stretch of the walls.

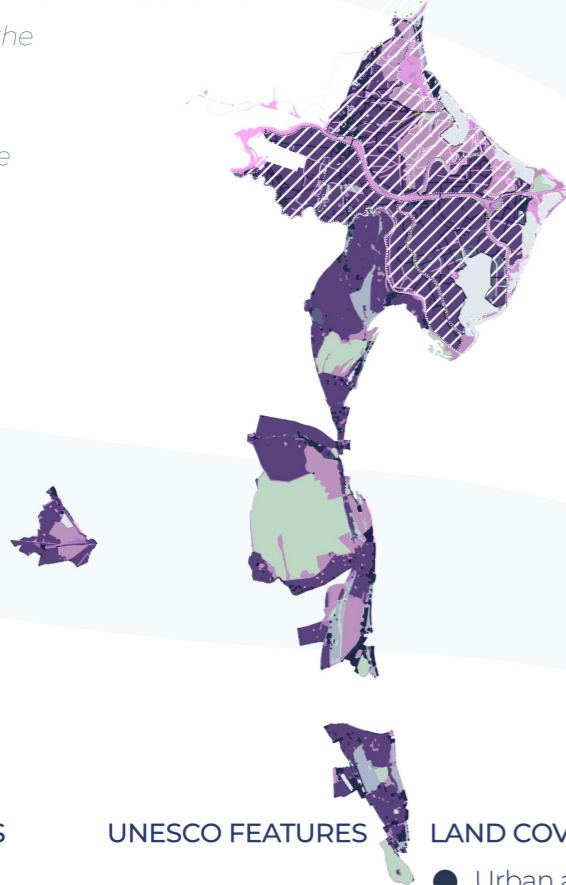
The map highlights the most sensitive areas categorized by the potential value of affected ecosystem services, based on the Burkhard matrix applied to the land cover of each site.

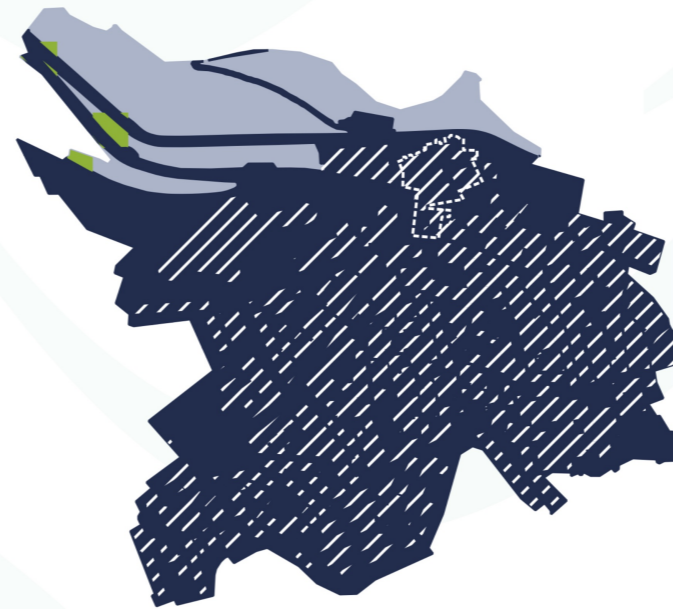
The map highlights the areas where the historical average Vegetation Health Index (VHI) has frequently indicated stress, showing three out of five impact classes. These are further subdivided into land cover units.

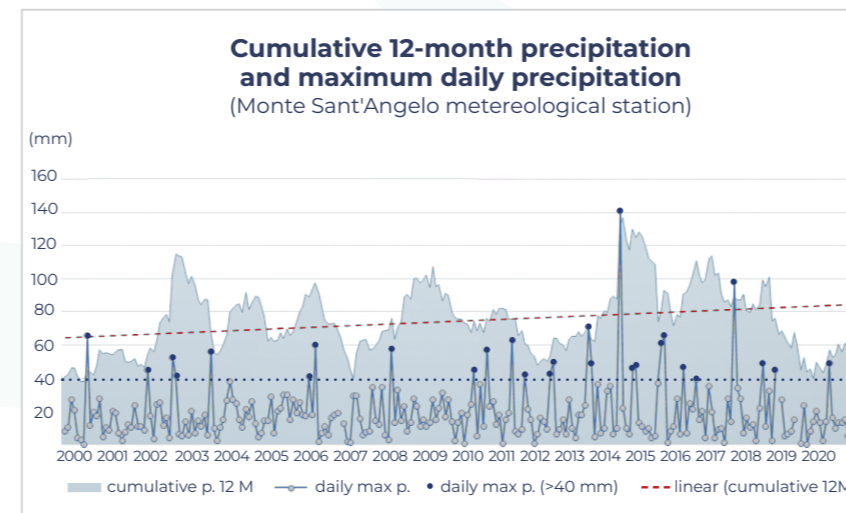
Maximum daily precipitation registered in 2014: 141 mm

An increase in maximum daily rainfall and annual cumulative precipitation is observed.

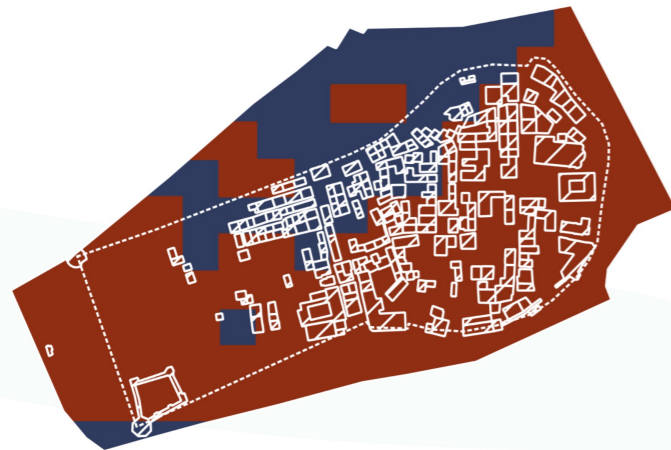
The map highlights the areas where the historical average Land Surface Temperature (LST) has frequently been exceeded, showing two out of five impact classes. These are further subdivided into land cover units.

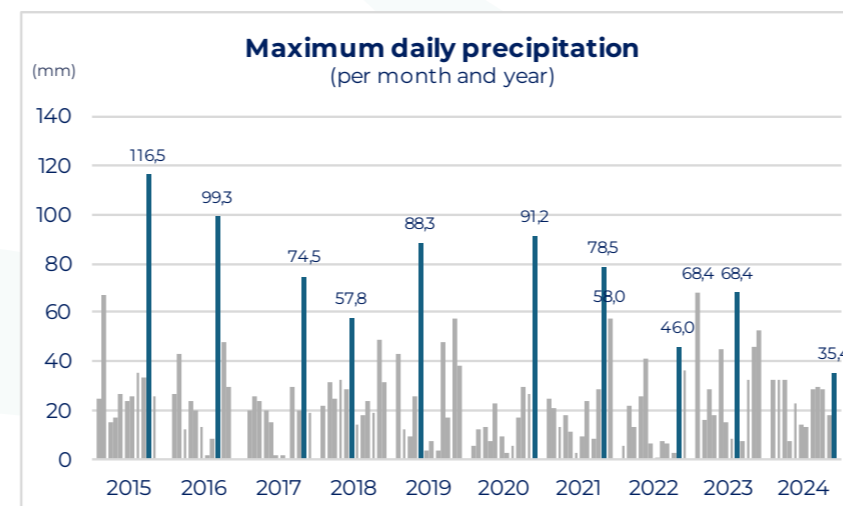
Maximum daily precipitation: October 2015: 116,5 mm

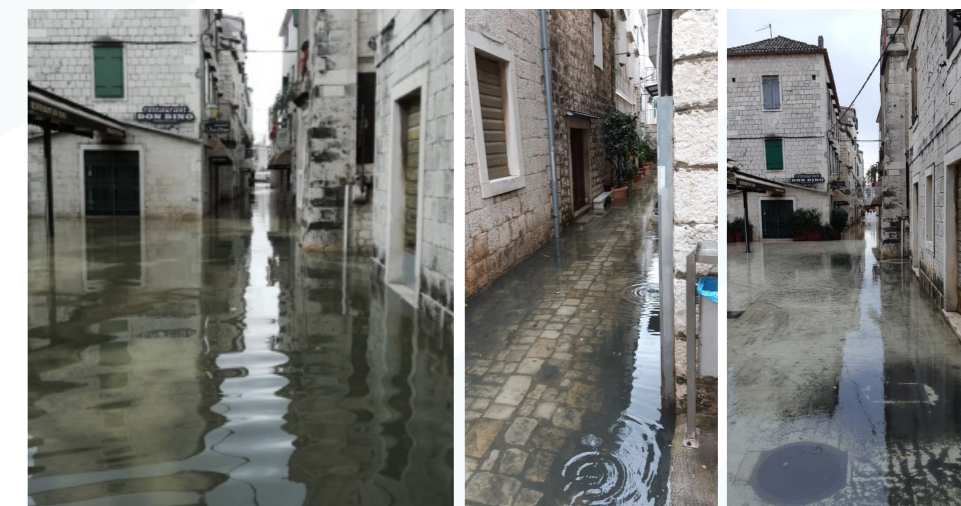
Last flood events:  
January 2019  
November 2019

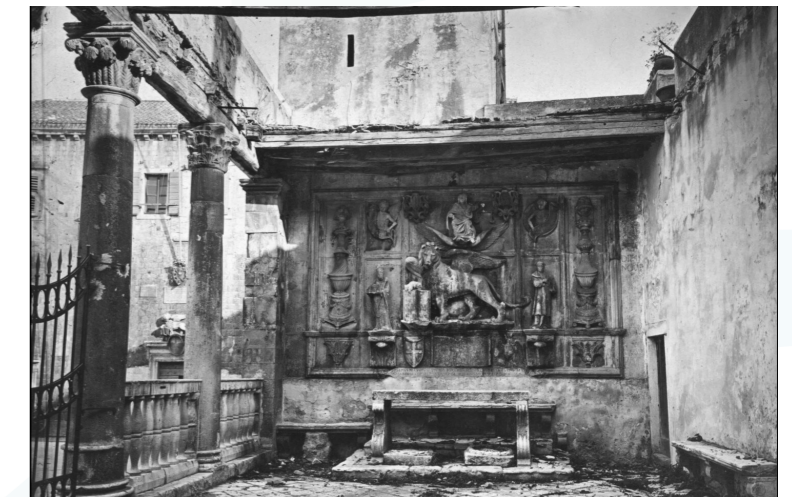
- a. State of the the loggia without a roof (photograph taken before the 1890 restoration). Source: *Photograph Collection of the Department of Art History of the Universität Wien.*
- b. Corner pillar with a Gothic capital and with a coat of arms featuring the heraldic traits of the Venetian Loredan family.
- c. Interior of the Loggia. Reliefs above the judge's table with the lion of St. Mark (archival photograph from the early 20th century). Source: *Babić, I. (2016)*

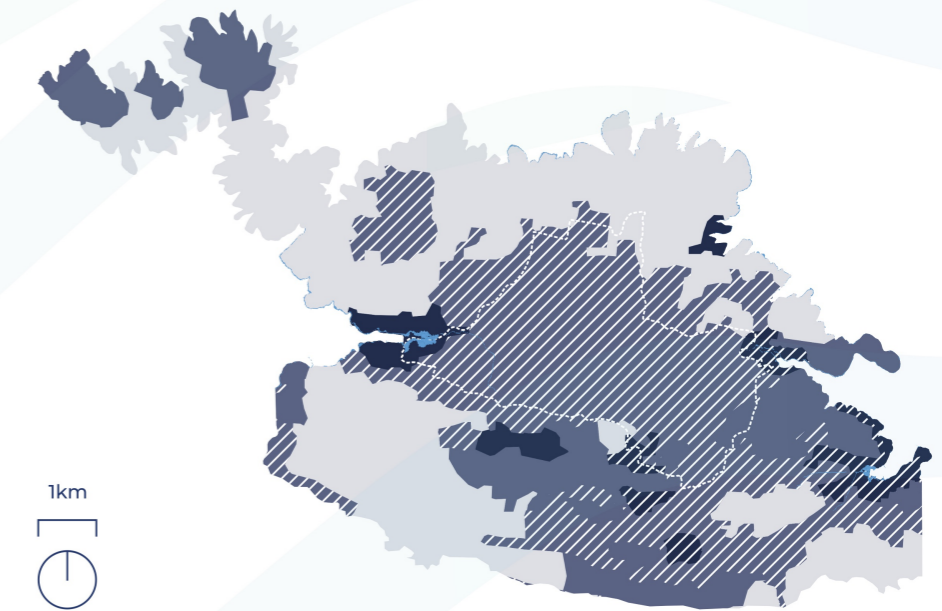
The map highlights areas at flood risk, identified through hazard probability scenarios based on the Flood Directive. For each site, the highest risk class has been selected, considering the regional Flood Risk Plans for each area.

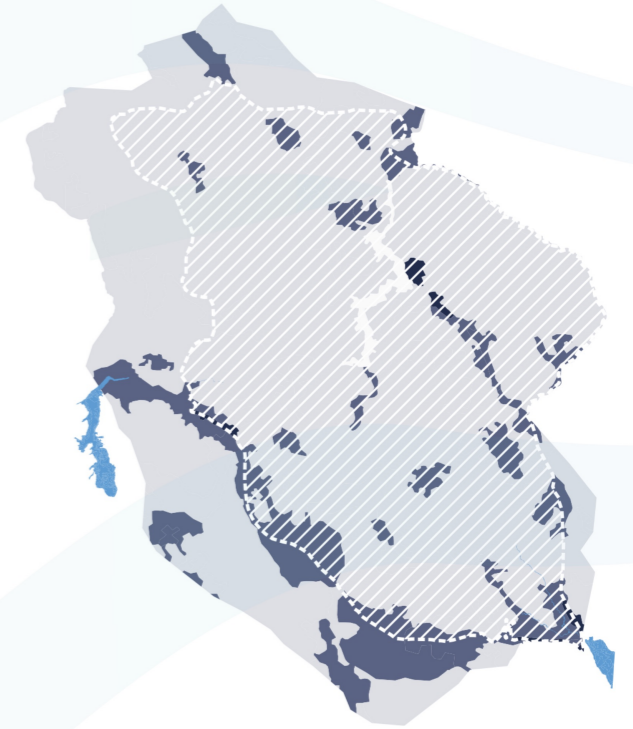
The map highlights areas at flood risk, identified through hazard probability scenarios based on the Flood Directive. For each site, the highest risk class has been selected, considering the regional Flood Risk Plans for each area.
