D.2.1.1 – Slope analysis report

**RESONANCE**

Project number:	ITHR0200175
Project acronym	RESONANCE
Project Title	impRoving landslidE riSk preventiOn aNd mAnagement iN Coastal arEas
Start of the project	March 2024
Duration	30 months

Project activity	2.1 Slope analisys
Deliverable number & name	D.2.1.1 Slope analysis report
Type of deliverable	Report
Language	English
Work Package Number and Title	WP2 - Slope analysis and risk definition
Work Package Leader	PP3-GRADRI

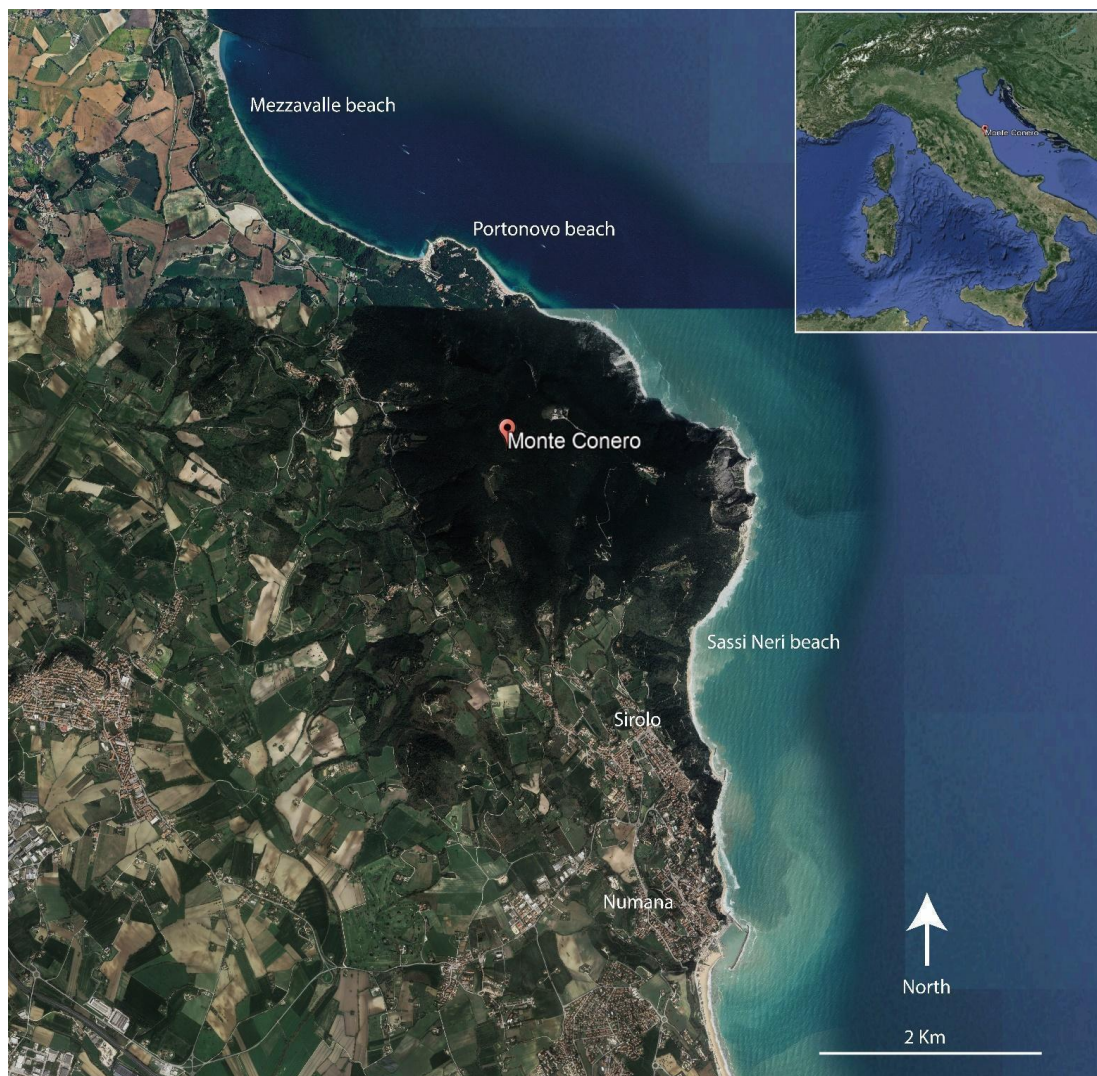
The Monte Conero promontory (572 m a.s.l.) is located along the coastal sector of Ancona (Marche Region, Central Italy) and extends for approximately 15 km along the Adriatic coastline, between the city of Ancona and the village of Numana. This coastal stretch is characterised by steep sea cliffs, generally exceeding 100 m in elevation. The study area is illustrated in Figure 1.

Figure 1 - The Monte Conero promontory.

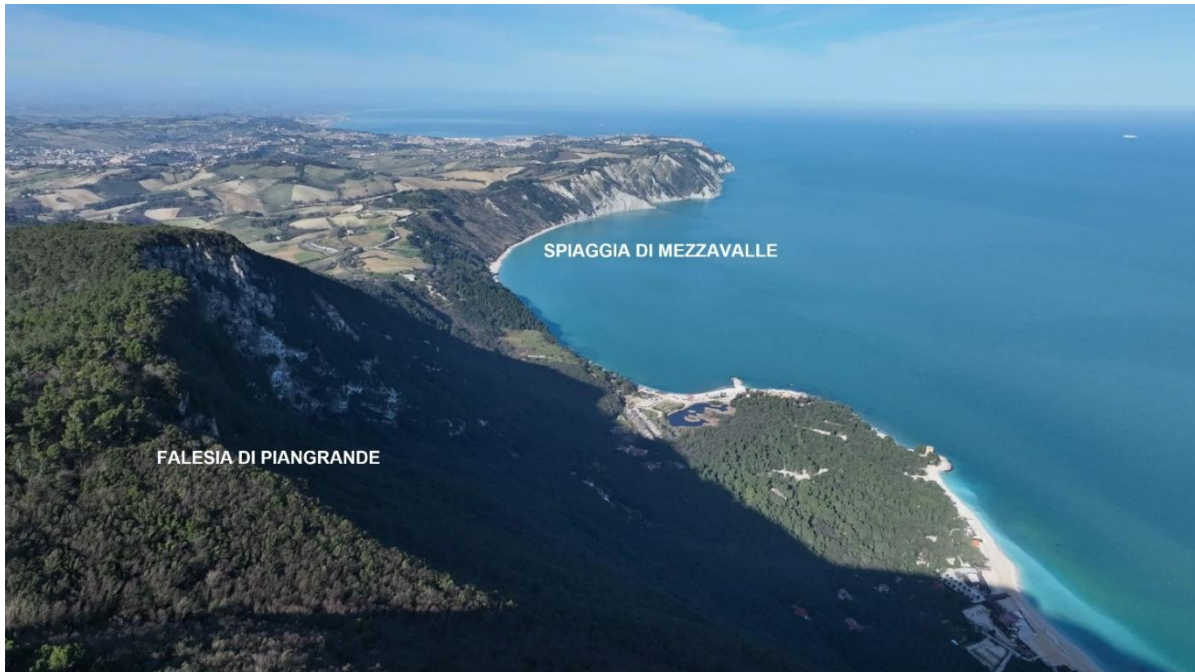
Figure 3 - The Mezzavalle beach and the Piangrande promontory in the Conero Regional Park.

The investigation focused on two main sectors: the Mezzavalle area and the Piangrande cliff (Figure 3). Mezzavalle beach is considered one of the most hazardous areas within the Conero Regional Park, as slope failures occur frequently, often posing a threat to visitors. In this sector, the cliffs are particularly high and steep and are mainly composed of marls and marly limestones.

The Piangrande cliff, located a few kilometres south of Mezzavalle beach, is characterised by recurrent large-scale slope failures that have affected the Portonovo coastal zone since at least medieval times (Montanari et al., 2016). Unlike Mezzavalle, the dominant lithology in this sector consists of Eocene marly limestones belonging to the Scaglia Rossa Formation, which form the steep rocky escarpments.

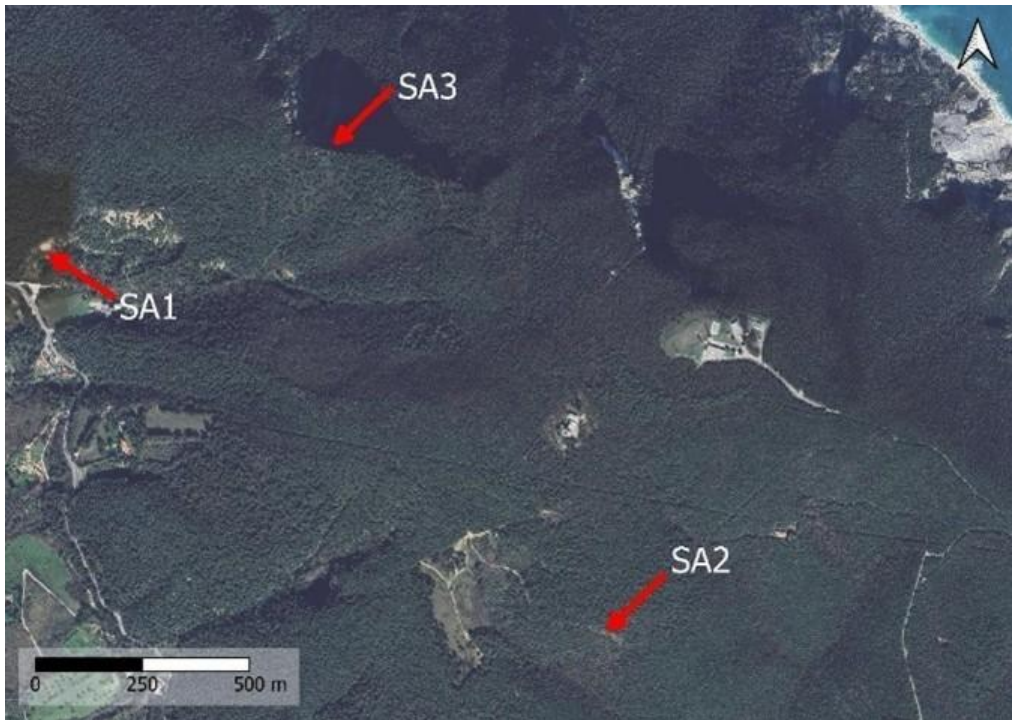
Figure 6 - Geographical location of geomechanical surveys.

Three representative survey sites within the Scaglia Rossa Formation were selected to investigate rock mass characteristics and local morphological conditions (Figure 6). Survey Area 1 (SA1, Poggio Quarry) is an abandoned quarry with well-exposed rock outcrops. Survey Area 2 (SA2, Riparo dello Speco) is located along the mid-slope of a southeast-facing cliff sector and corresponds to a cave recently identified in the study area. Survey Area 3 (SA3, Piangrande cliff) corresponds to the main coastal cliff sector investigated in this work and is characterised by pronounced structural complexity and active instability processes.

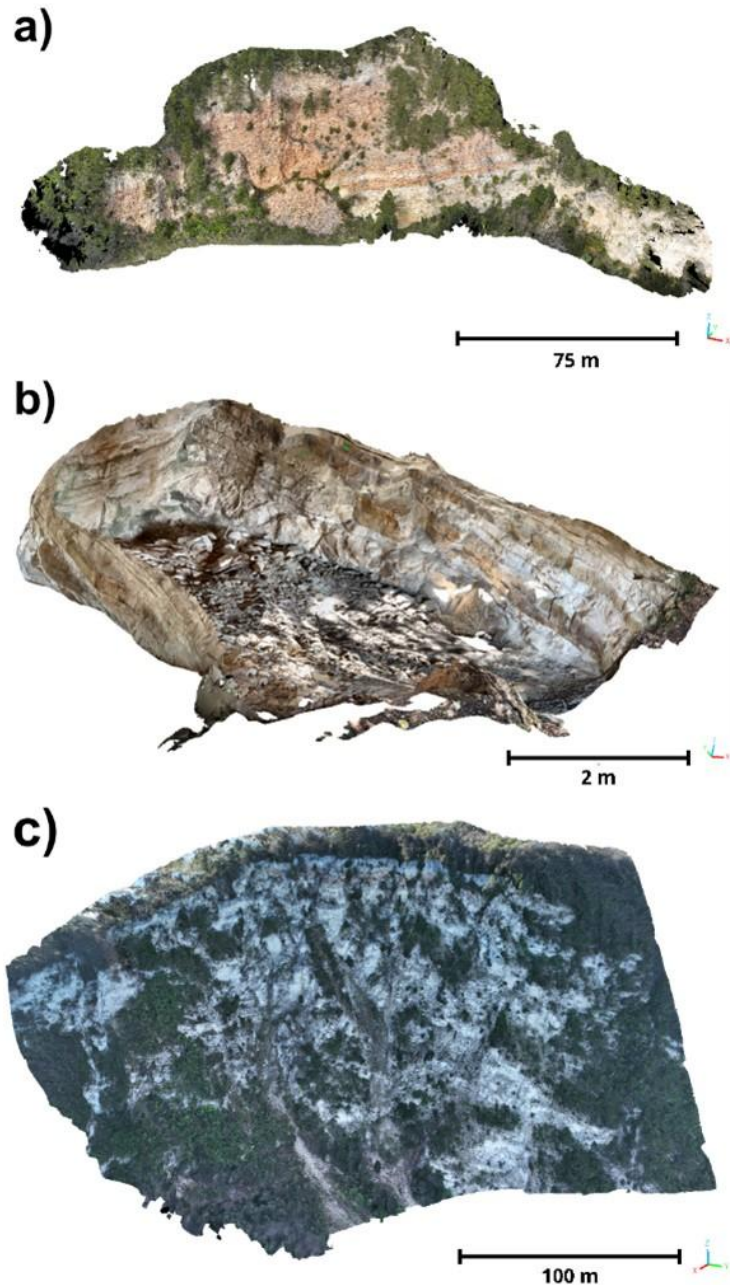
Figure 7 - Three-dimensional models used for structural and geomorphological analyses: (a) UAV-based photogrammetric model of the Cava Poggio quarry; (b) LiDAR-derived 3D model of the Riparo dello Speco cave acquired with an iPad Pro; (c) UAV-based photogrammetric model of the Piangrande coastal cliff.

The resulting 3D models from the three sites are shown in Figure 7. For SA1 and SA3, the models were derived from UAV photogrammetry, whereas for SA2 the model was derived from LiDAR acquisition with an iPad Pro.

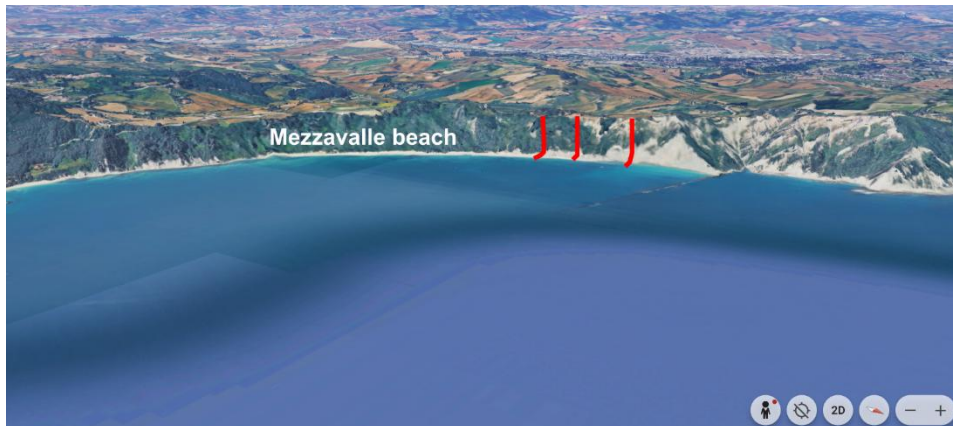
Figure 17 - Location of the three analysed topographic sections within the Mezzavalle area. The sections were selected to capture the main variations in slope geometry and near-surface conditions along the analysed coastal sector.

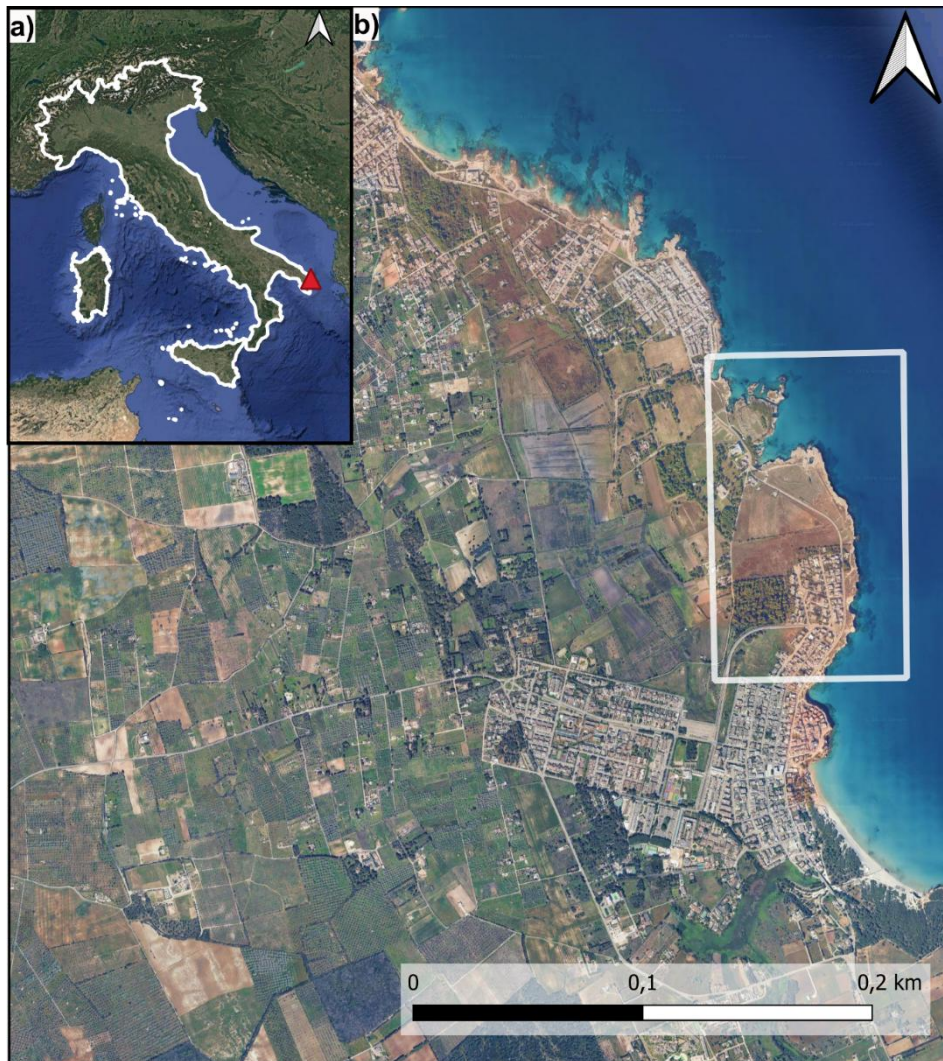
The Roca Vecchia coastal cliff is located in the central sector of the Salento Peninsula, along the Adriatic coast of the Province of Lecce, in southern Italy (Figure 19).

Figure 19 - Geographical localisation of the study area and aerial view of the area surrounding Grotta della Poesia, Roca Vecchia (LE).

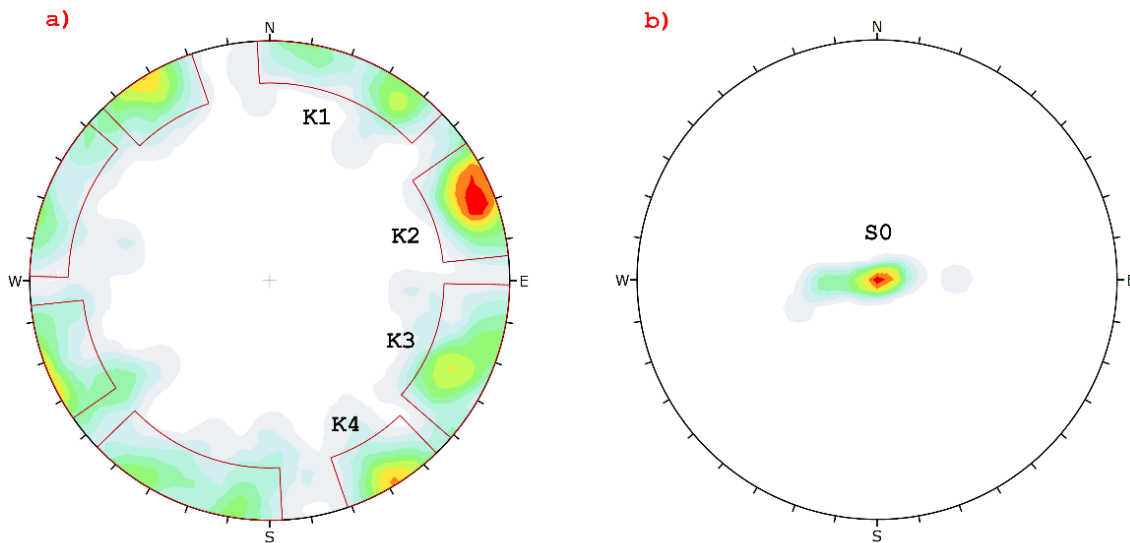
Figure 26 - Stereographic projections of the virtual geomechanical survey.

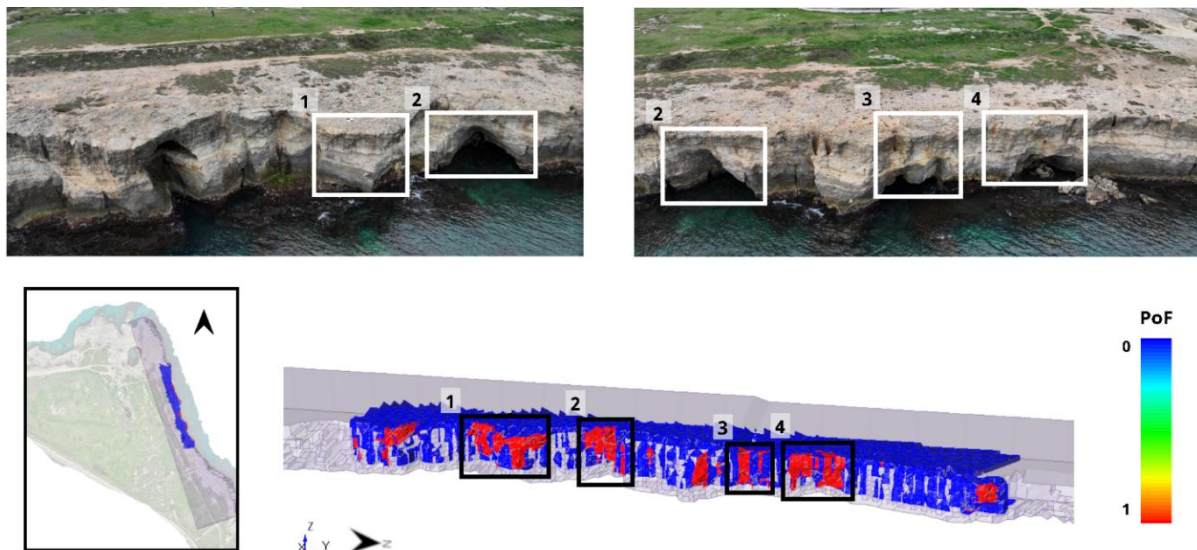
Figure 28 - Block Stability Analysis. The highlighted blocks indicate the unstable areas identified in the UAV images and in the RocSlope3 simulations. The legend represents the Probability of Failure (PoF).

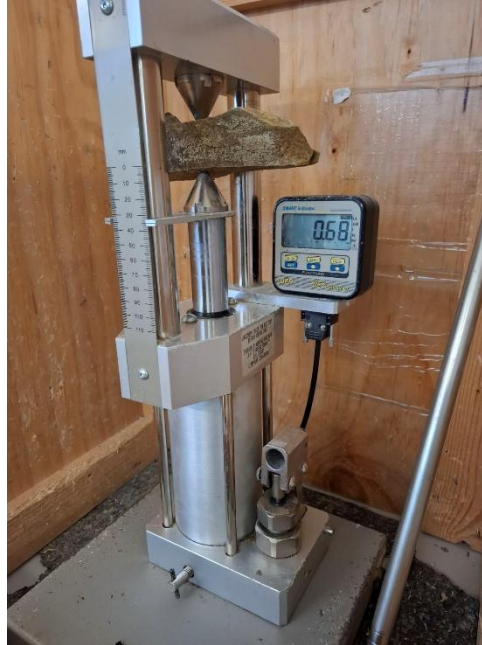
Figure 31 - Point Load test testing at the Geotechnical Laboratory, University of Rijeka, Faculty of Civil Engineering.

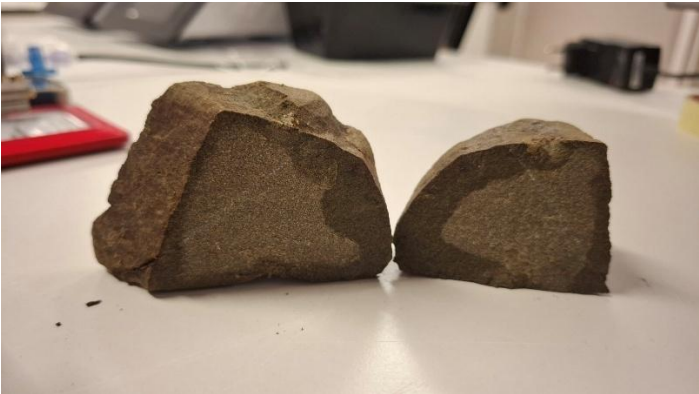
Point Load Test results for samples with in situ water content, considering the corresponding conversion factor gave the mean UCS value of 55,00MPa at location 1 and the mean 68,70 MPa at the location 2. Table 6 shows the result after PLT testing after 24h wetting. The results show that the UCS values increased at location 1 compared with the previous to the value 68,70 MPa at location 1 and value 67,41 MPa at the location 2. It is expected that the failure likely initiated through the saturated zone, where the intergranular bonding is reduced, contributing to reduced Point Load Strength Index under wet conditions, however, the observations and the results (especially at the Location 1) did not confirm these expectations. The sandstone specimens show a clearly defined darker zone, indicating water penetration after wetting (Figure 32). The penetration front is irregular but well delineated, forming a lens-

Figure 32 - Sandstone sample after testing: different water penetration patterns.

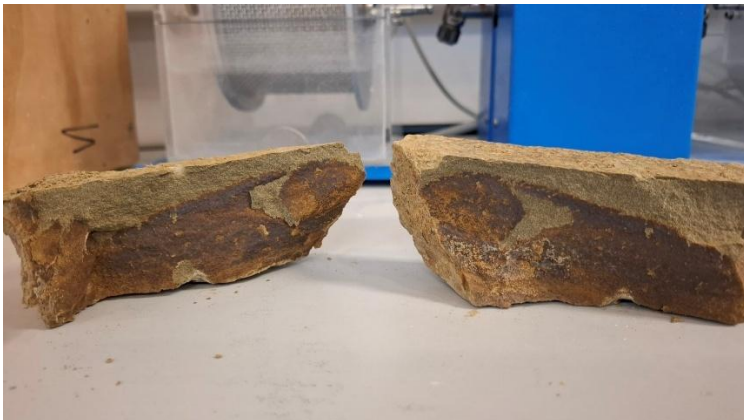
Figure 33 - Dark brownish areas inside the sample.

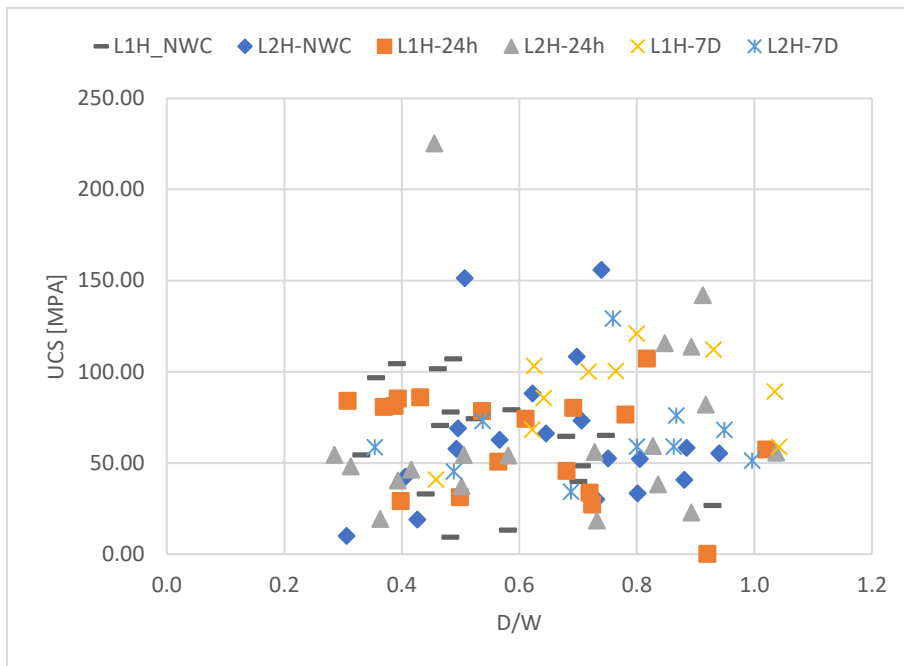
Figure 34 - Sandstone mean UCS values considering different D/W ratio.

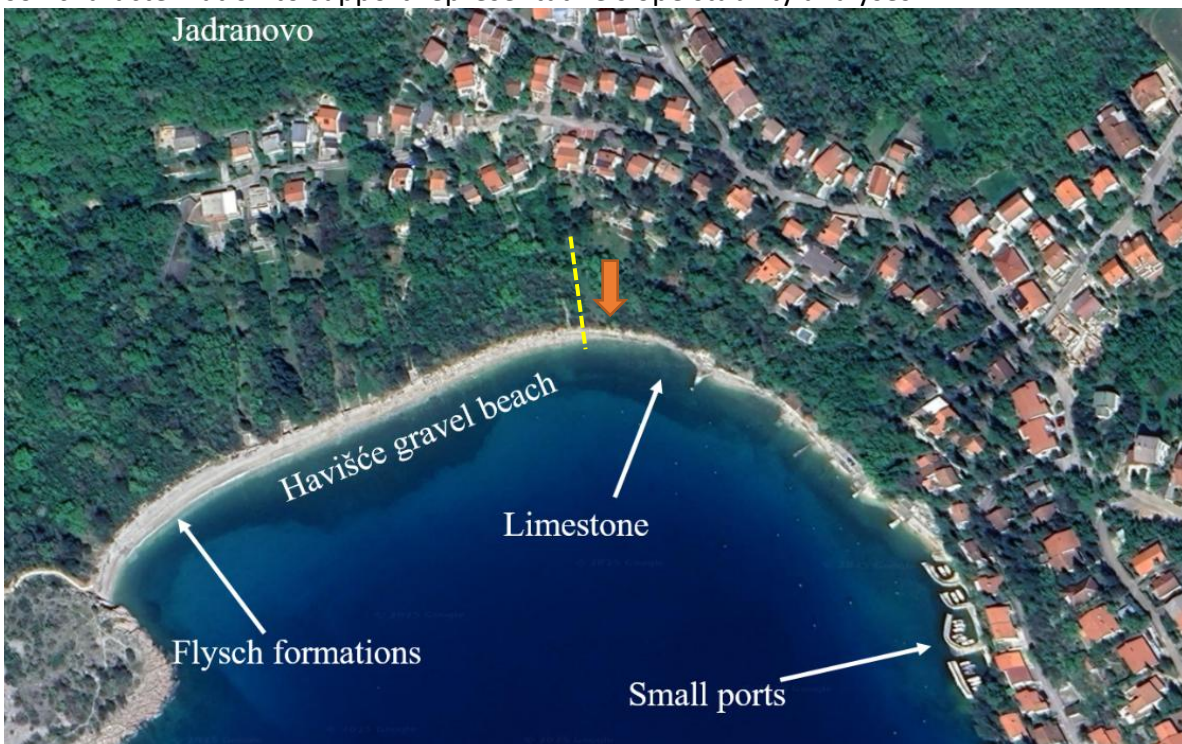
Figure 35 - Monitoring and soil sampling location (45.219882, 14.616521), indicated by a red arrow, next to the geophysical survey location (indicated by a dashed yellow line).

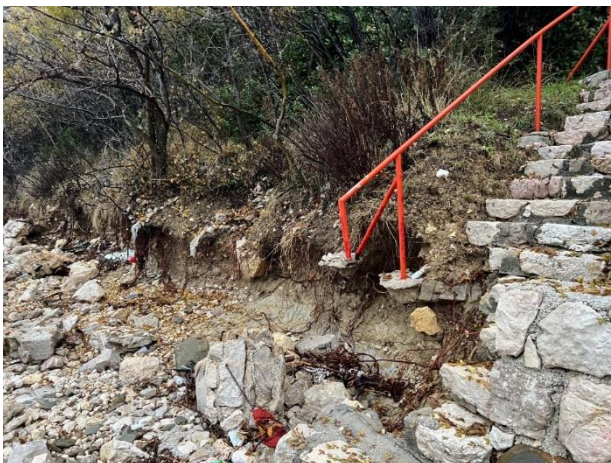
Figure 36 - Examples of past local instabilities at the sampling location due to the slope's toe erosion.

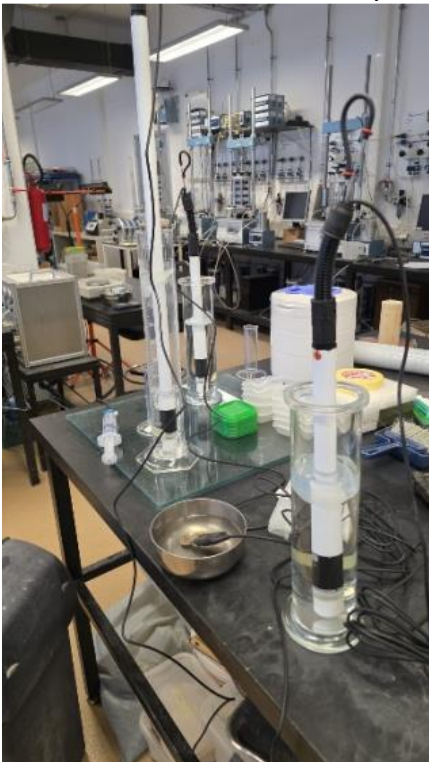
Figure 37 - Testing of the monitoring equipment under laboratory conditions prior to field installation.

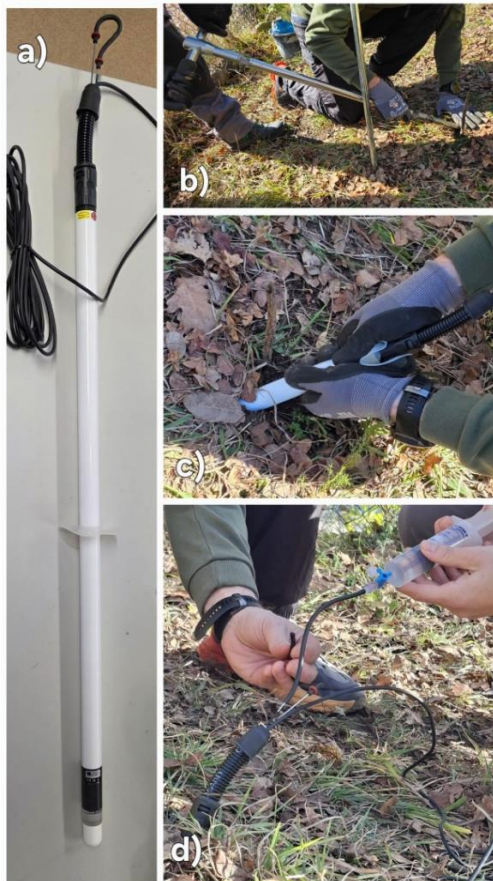
TEROS 32 sensors were installed at three different depths of 15, 30 and 60 cm and they are used to measure both positive and negative pore water pressure (Figure 39). Setting up TEROS 32 required on-field filling of sensor with syringe of demineralized and deaired water.

Figure 39 - a) TEROS 32; b) Drilling the hole with auger; c) Pushing TEROS 32 into drilled hole; d) Filling TEROS 32 with water syringe.

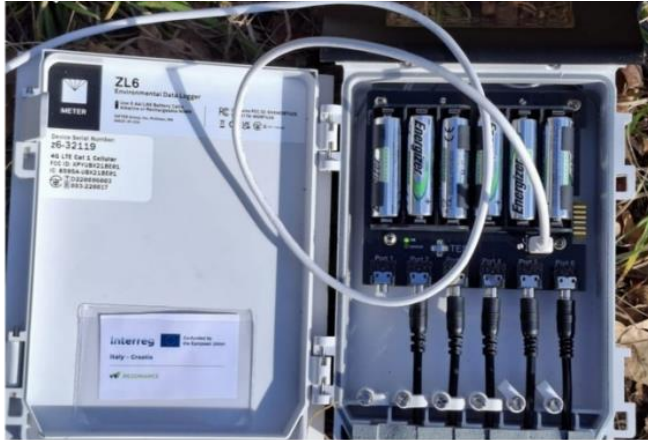
Figure 40 - Data on soil moisture content changes, as seen on ZENTRA Cloud service (top); and data logger ZL6 with all the instruments connected (bottom).

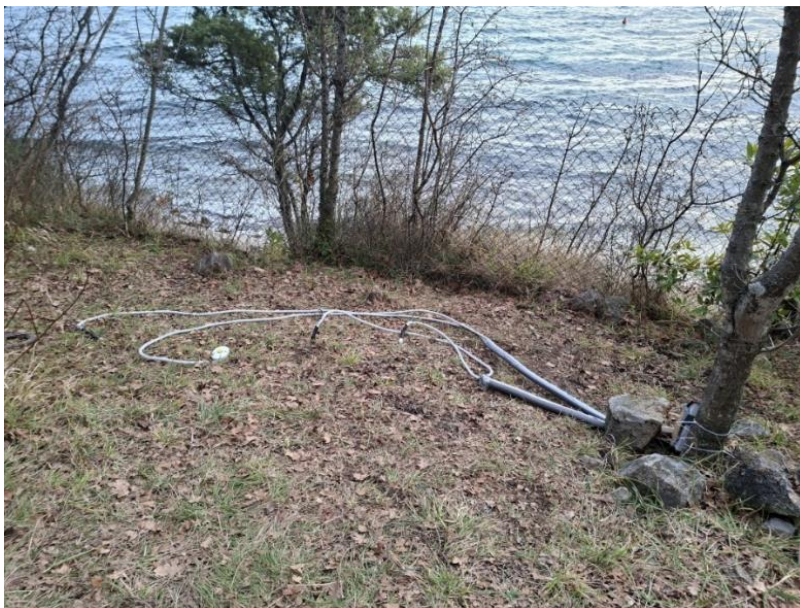
Figure 41 - Sampling and monitoring location in Havišće Bay.

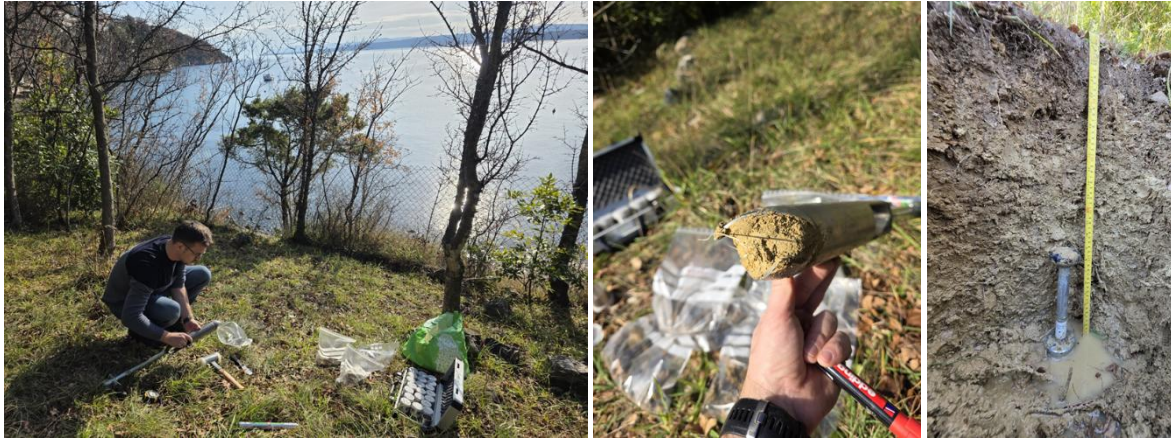
The samples were taken at the same depths as the TEROS 32 sensors were set at, 15,30 and 60 cm, in order to ensure consistency between field measurements and laboratory analyses. Some details on sample collection are reported in Figure 42.

Figure 42 - Some details on collection of soil samples.

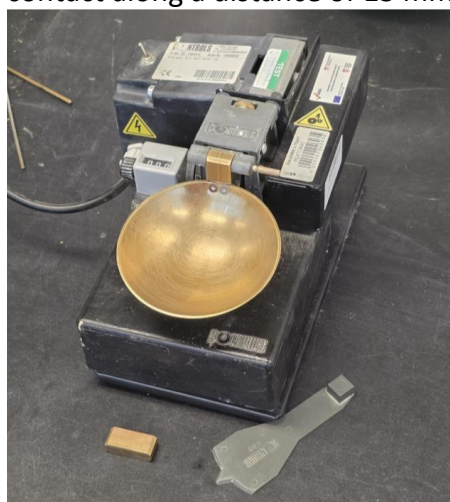
Liquid limits were determined using liquid limit device shown in Figure 44. Procedure was done following ASTM standard D 4318 – 05. Soil paste is prepared from soil that passed through 0,425 mm sieve and applied to the cup using a spatula after which groove is formed in the soil by drawing the grooving tool through the middle of the soil. Cup is lifted and dropped by the device at rate of 2 drops per second until the two halves of the soil come in contact along a distance of 13 mm.

Figure 44 - The liquid limit device.

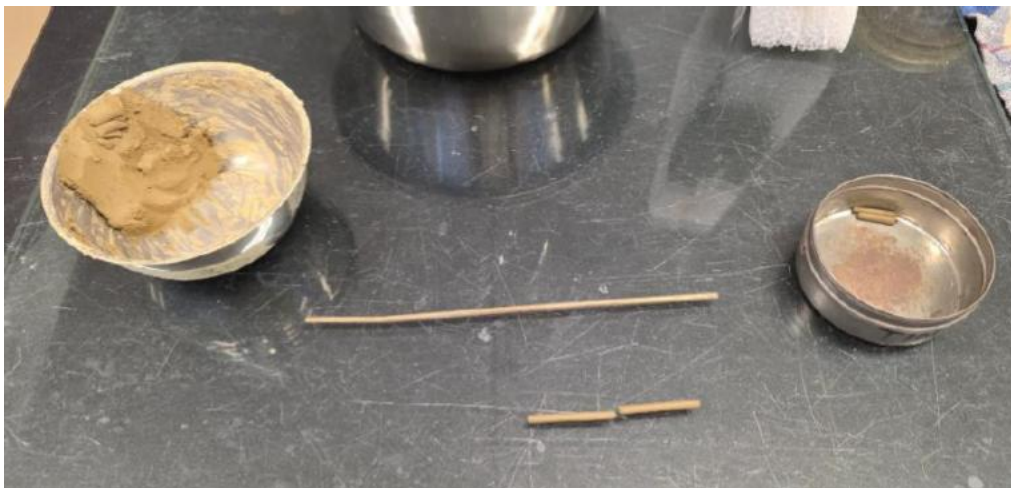
Plastic limits were determined following again ASTM D4318 – 05 procedure. Soil mass was rolled using hand method between palm and glass pane with enough pressure to deform it so that its diameter reaches 3.2 mm. Procedure was repeated until thread of soil broke at 3,2 mm diameter and couldn't be rolled further (Figure 48), procedure was repeated for five samples with two of those, representing the minimum and maximum values, being excluded from the analysis. Plastic limits for soils at each depth are as follows: for 15 cm depth 26%, for 30cm depth 20% and for 60 cm depth 22%.

Figure 48 - Rolling of soil mass thread for plastic limit determination.

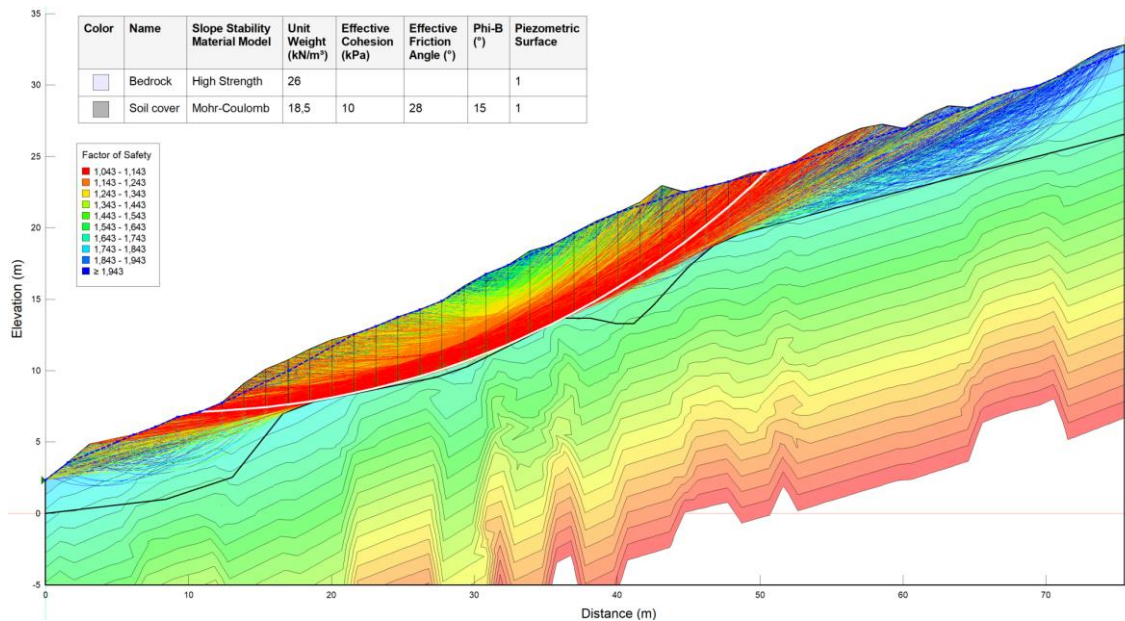
Figure 54 - LEM-based slope stability results for the wet scenario with the critical sliding surface and the corresponding global minimum factor of safety, FoSmin=1.04.

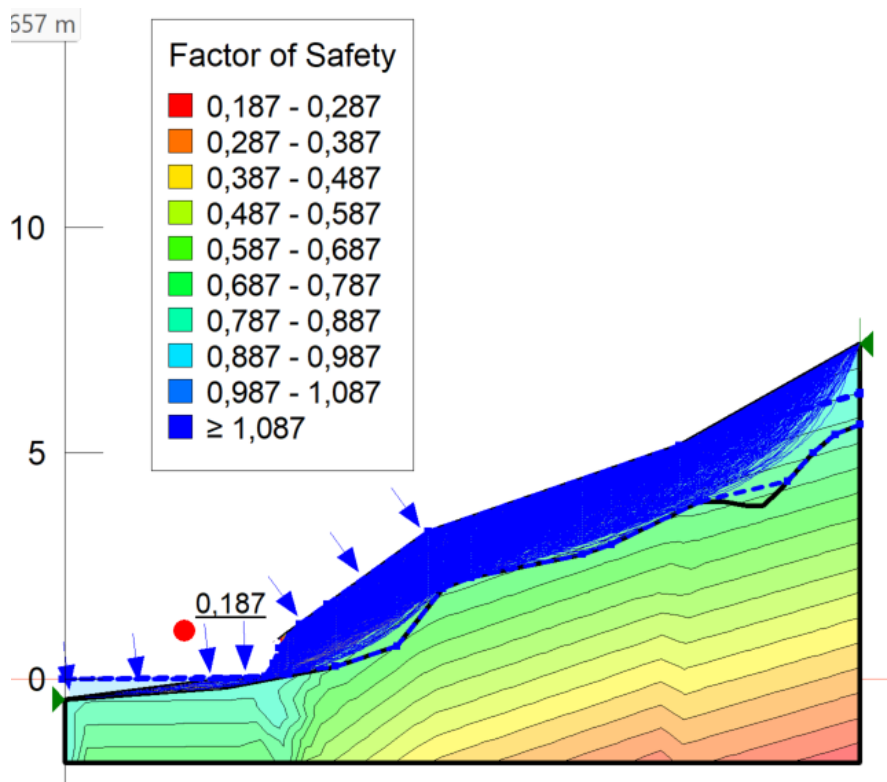
Figure 60 - Slope stability results for the model with modifications to slope geometry simulating the erosion at the toe and wetting-induced reduction in soil strength.

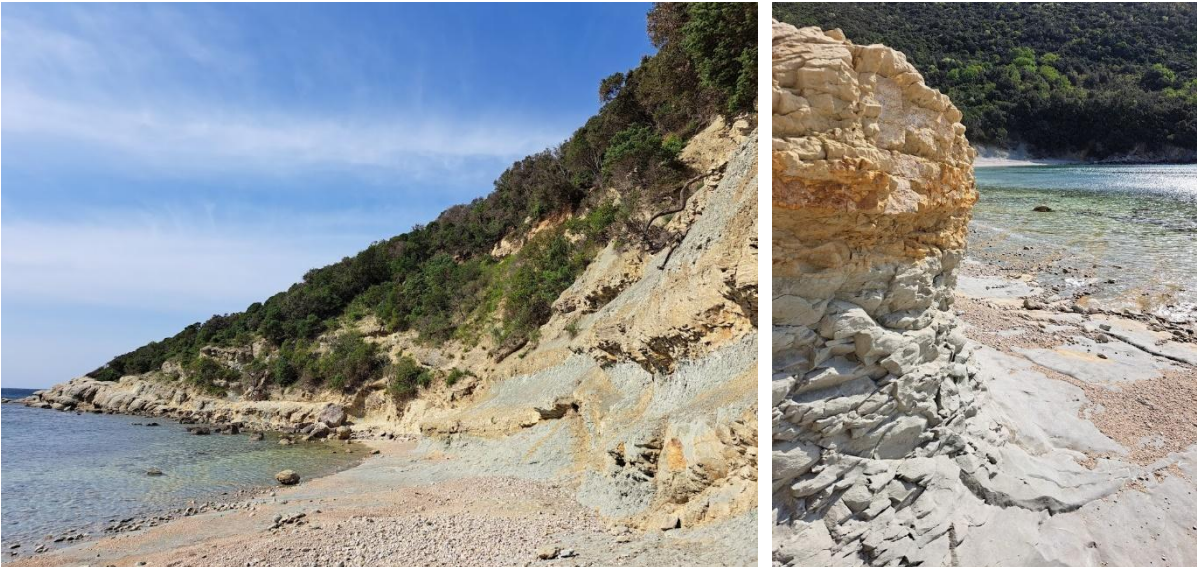
Figure 63 - Alteration of differently discoloured layers of marls at the foot of the slope.

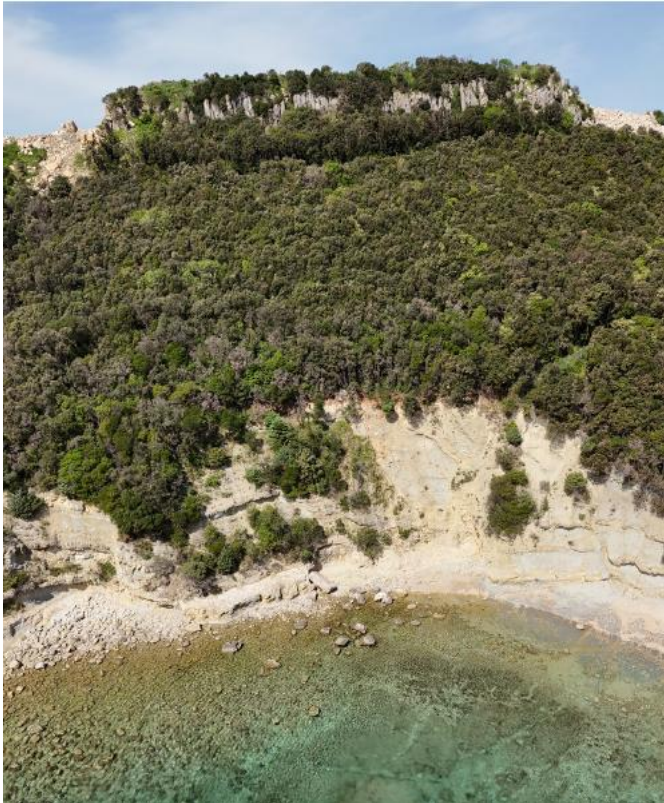
The middle part of the slope consists of the previously mentioned marl layers, covered by thin residual soil and colluvium, which are forested, while the top of the slope is formed by a limestone plate (Figure 64).

Figure 64 - View of the slope at the Brovinje site.

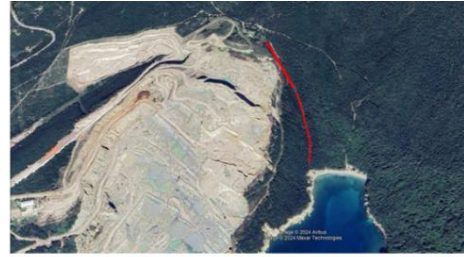
Figure 65 - Position of the geoelectrical profile n°4 at the Brovinje site and 2D distribution of the resistivity.

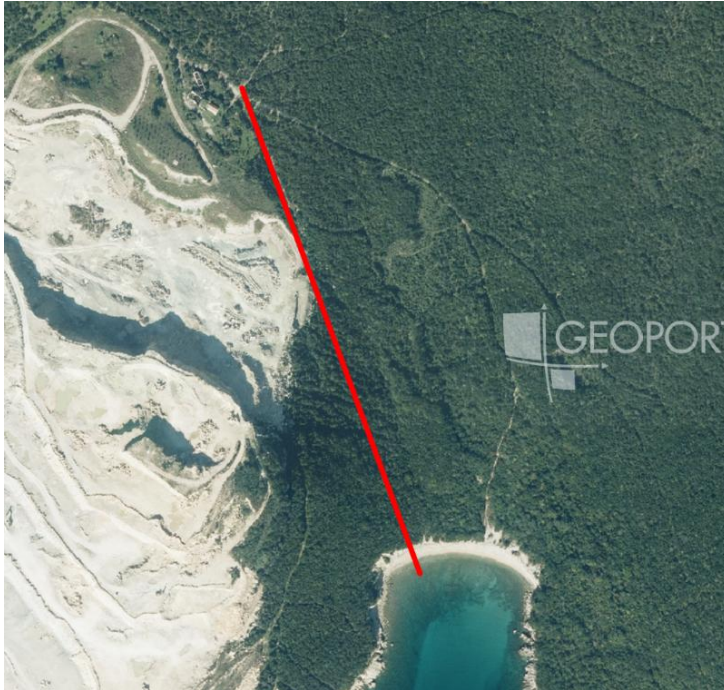
Slope stability analyses were performed at the surface profile obtained from the digital terrain model (DTM) of Brovinje with 1 m resolution created from UAV photogrammetry through this RESONANCE project or obtained by the Croatian State Geodetic Administration (Figure 66).

Figure 66 - Position of the longitudinal profile on the orthophoto map for slope stability analyses at Brovinje site.

The risk map with zones of different risk levels, created according to rock paths (Figure 79) and the heat map (Figure 80), was calibrated using the large number of blocks at the slope toe and in the gully along the slope identified in the field (Figure 74), as well as rockfall traces visible along the slope on the orthophoto map (Figure 66).

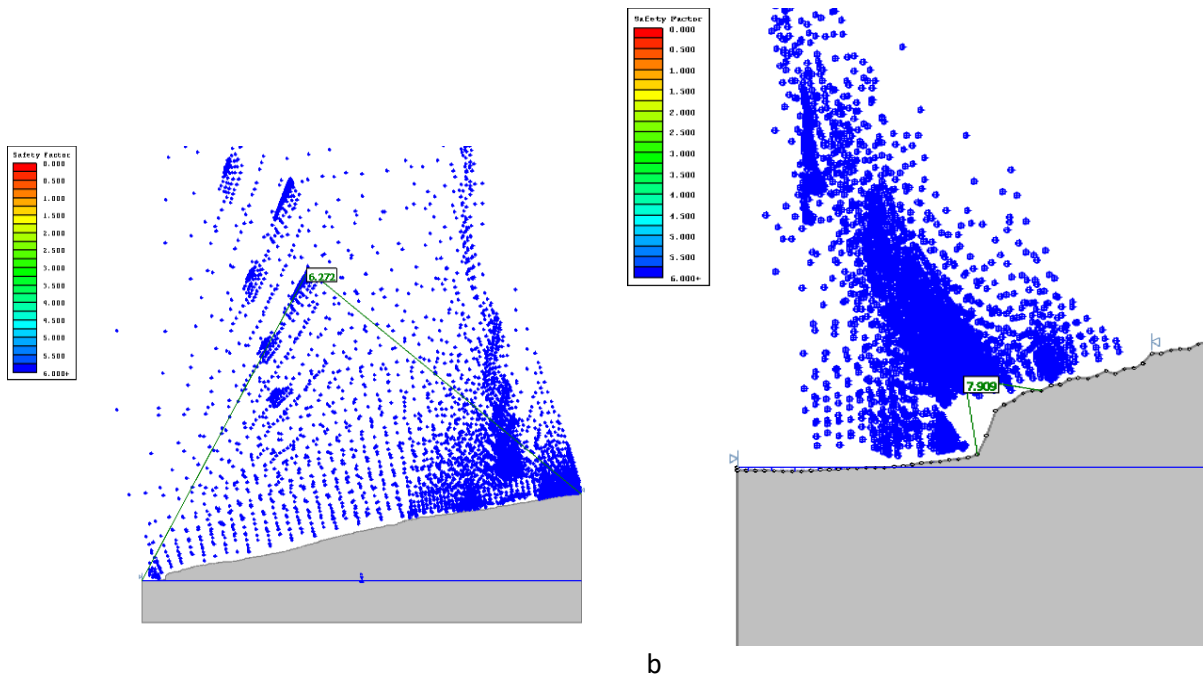
Figure 70 - Factor of safety obtained in the Slide2 program of the slope built in marls with properties at location 1 a) for the entire slope, b) at the foot of the slope.

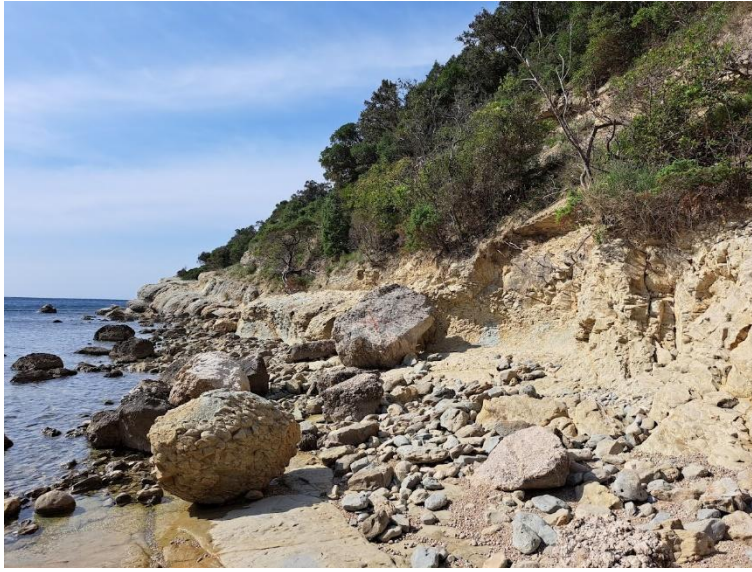
a

Blocks of marl, breccia, and limestone are visible at the toe of the slope, on the beach gravel and inside the sea (Figure 74a), as well as in the gully along the slope (Figure 74b), indicating the need to conduct two-dimensional and three-dimensional rockfall analyses.

Figure 74 - Marl, breccia and limestone blocks a) at the toe of the slope, b) in the gully along the slope.

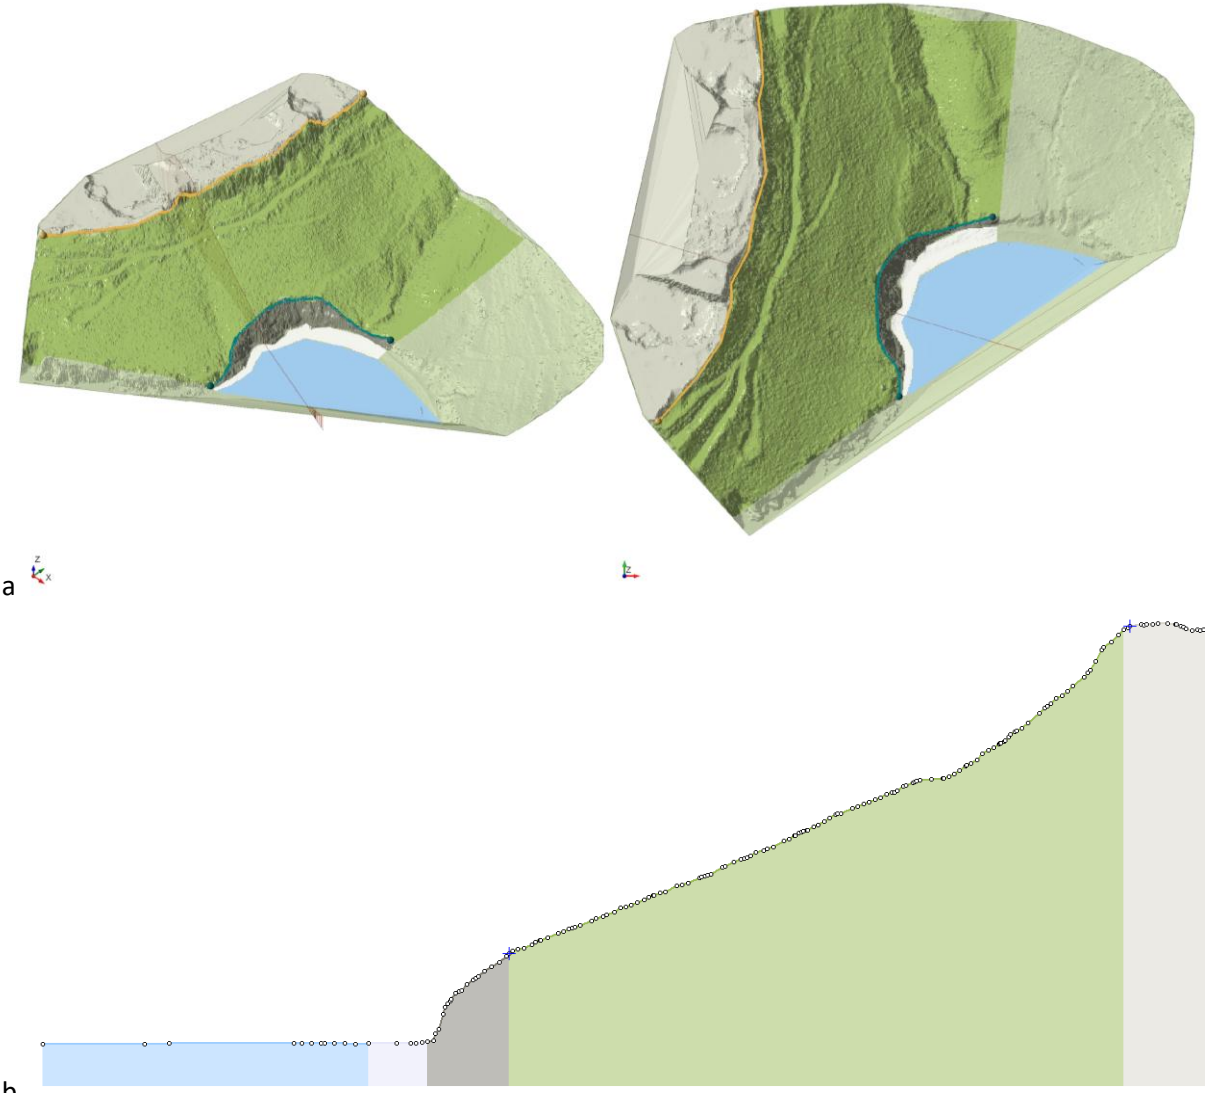
Figure 81 - a) 3D model with position of cross section in RocFall3 software, b) cross-section of the model in RocFall2 software showing regions with different material properties and the positions of seeder points.
